# **EVALUATION OF RISK AND POSSIBLE MITIGATION SCHEMES FOR PREVIOUSLY UNIDENTIFIED HAZARDS**

William Linzey, Micah McCutchan, and Michael Traskos  
Lectromechanical Design Company

Richard Gilbrech, Ph.D.  
NASA Langley Research Center

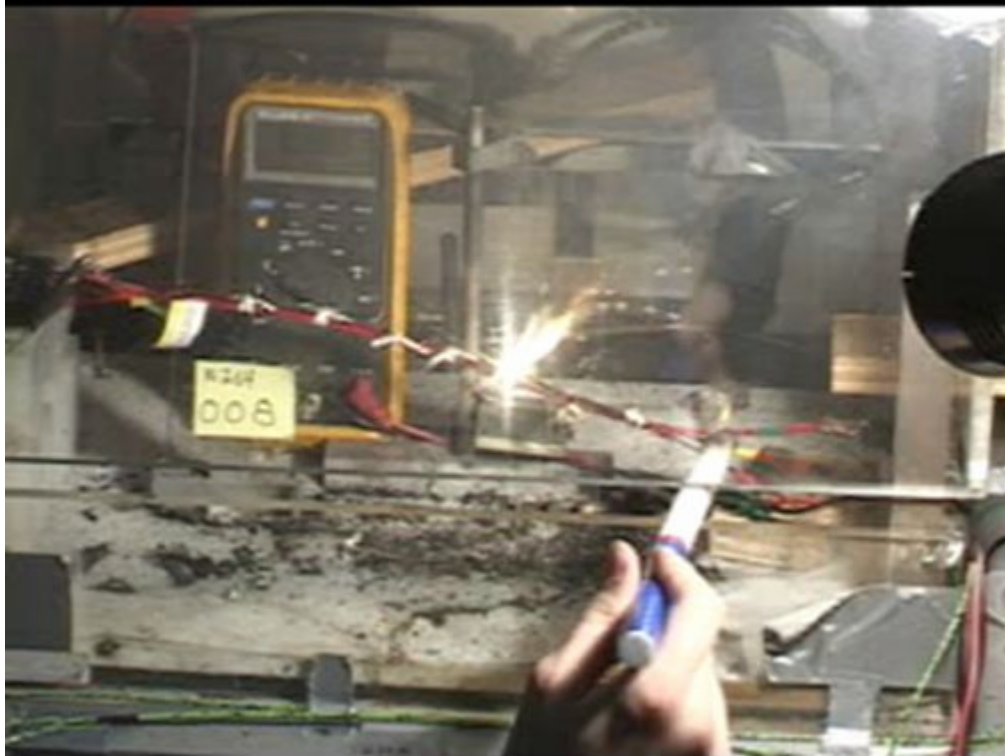
**Figure 5. Test N264-008 In Progress**

After all preliminary checks were performed, the heater circuits were energized and the oil/graphite mixture was used to initiate the arc. The arc was allowed to propagate the length of the sample. The arc event tripped the circuit protection, self-extinguished the arc, or stopped when it reached the end of the sample. After the power was turned off, the specimen was removed from the testing chamber and all test information was recorded. A visual inspection of the sample gave preliminary indications of the effectiveness of the protection scheme. For each sample, wet dielectric voltage withstand (DVW) test was used to determine if the insulation of the fuel/ox wires was actually compromised. Figure 5 is a still shot (captured from video) of Test N264-008 in progress.

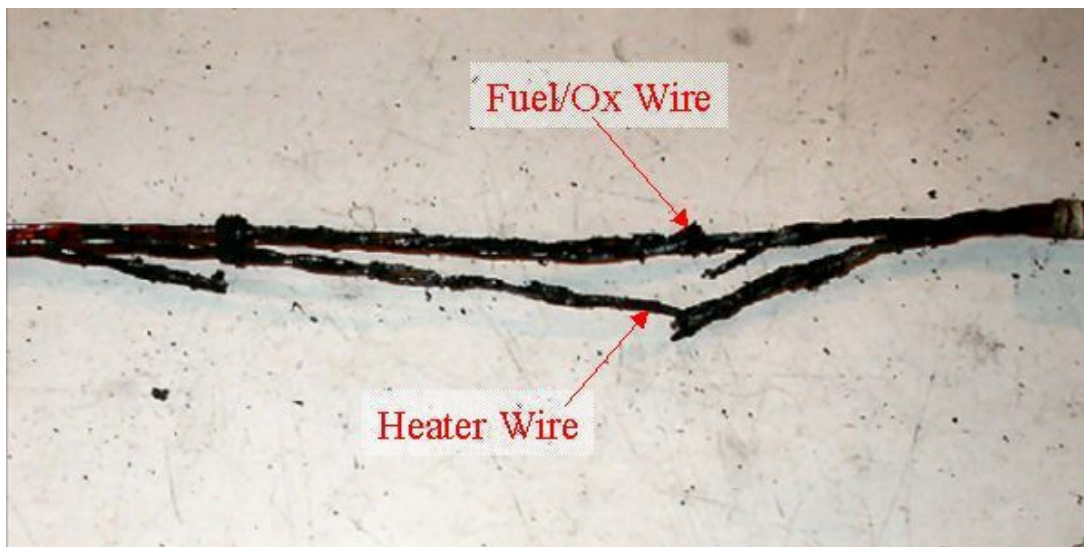
**Figure 9. Post-test Photo of Test Specimen 008 (15 amp fuse)**

Figure 9 is the post-test photo of Test Specimen 008 which used 15-amp fuses. The figure shows the extensive damage to both the fuel/ox wire and the heater wire. A section of several of the heater wires have been destroyed (evaporated) in the arc.

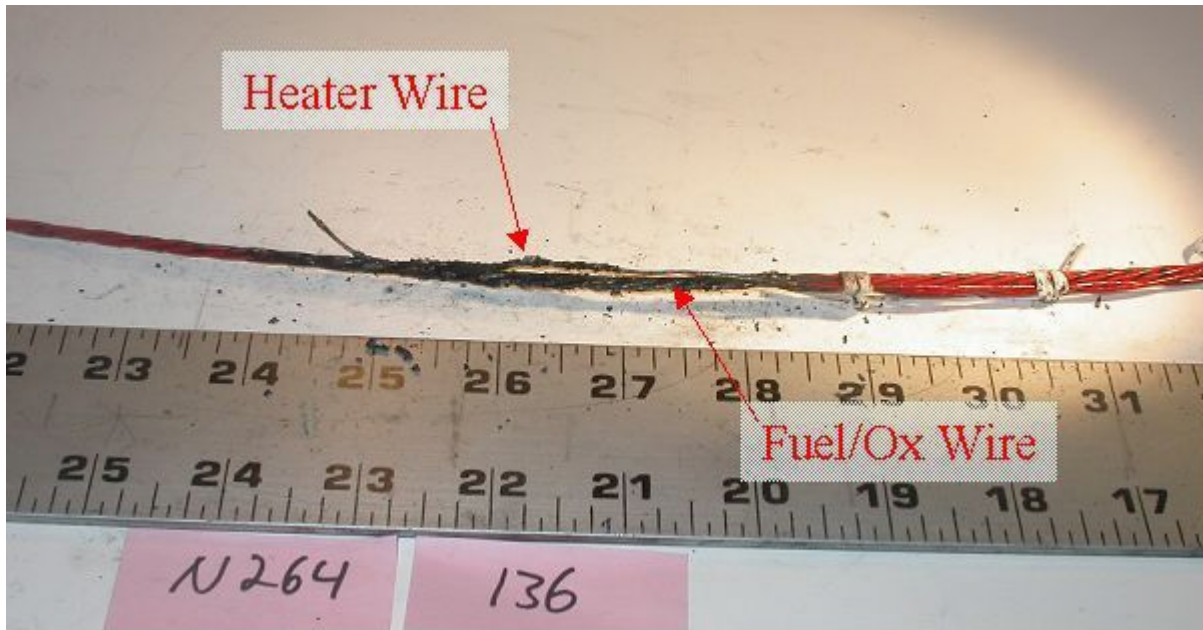
**Figure 10. Post-test Photo of Test Specimen 136 (10 amp fuse)**

Figure 10 shows the post-test photo from Test Specimen 136 which used 10-amp fuses. There is much less damage than in Figure 9, as the 10-amp fuse protected the test specimen. However, there still is significant damage to the fuel/ox wires.

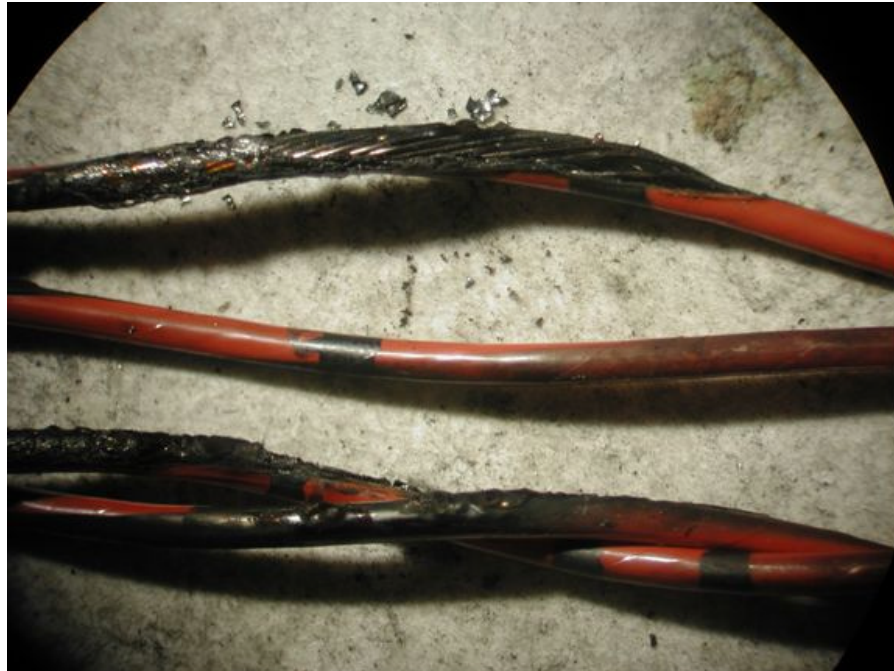
**Figure 11. Photomicrograph of Damage to Fuel/Ox Wires**

Figure 11 shows a photomicrograph of the damage to the fuel/ox wire of Test Specimen 004. The insulation of the upper wire has been destroyed in the arc and the conductor is exposed. This wire was connected to the high side of the coil. The lower return wires are also damaged and exhibit exposed conductors.

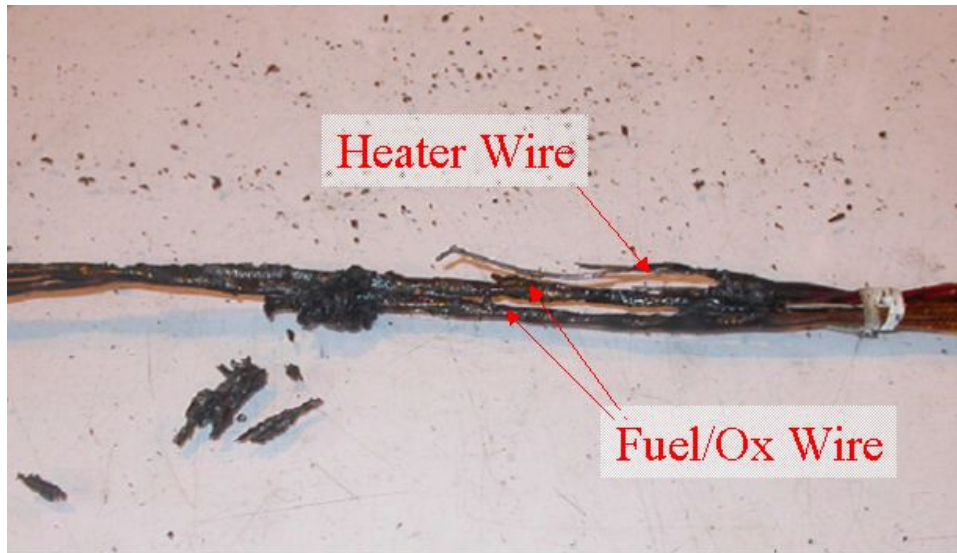
**Figure 13. Post-test Photos of Test Specimen 012**

Figure 13 shows the post-test photo of Test Specimen 012. There has been damage to the fuel/ox wires and the shield has been exposed in several places. Because of the heat generated by arcing to the shield, it remains possible that the fuel/ox wire inside the shield may be heat damaged. However, as long as the shield is intact, it is impossible for voltage and current to be transferred from the arc to the inner wires.

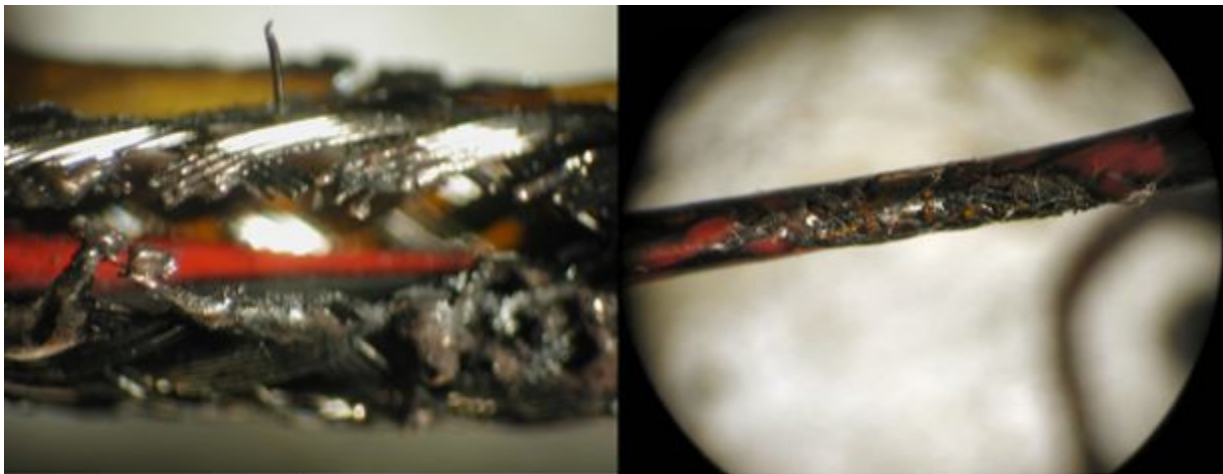
Figure 14a shows an example of a breach in the shield. Figure 14b shows damage to an inner fuel/ox wire at the point that it failed the wet DVW test. There is not an obvious breach exposing the conductor, but the insulation had been damage such that it could not prevent current conduction.

**Figure 14a. Close-up of Damaged Shield  
(Test Specimen 011)**

**14b. Photomicrograph of the Fuel/Ox Wire at the  
spot that it failed the wet DWV  
(Test Specimen 011)**

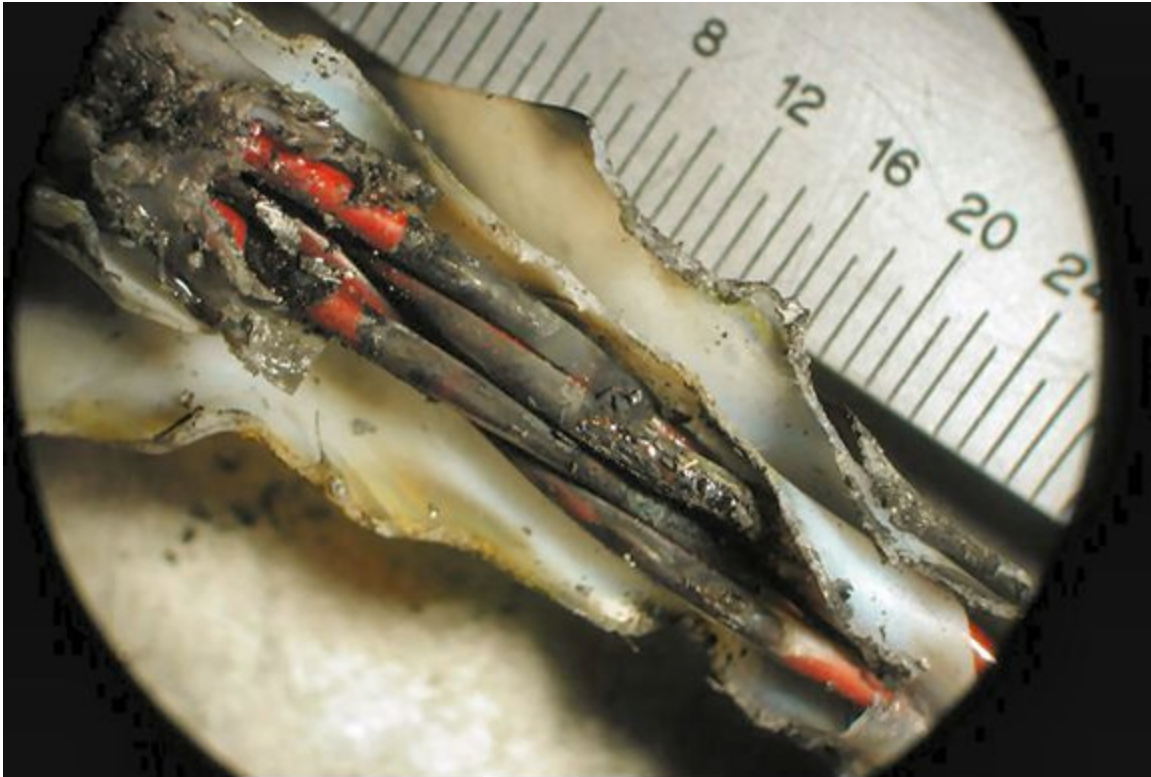
**Figure 15. Post-test Photomicrograph of Fuel/Ox Wire Test Specimen 076**

Figure 15 is a photomicrograph of Test Specimen 076. This was the worst-case damage to the fuel/ox wire of any of the protected specimens. Despite the damage, this wire passed the post-test wet DVW as there was still sufficient wire insulation remaining. There was no voltage or current measured across the coil of this specimen and no valve movement detected by the accelerometers.
