# **EVALUATION OF RISK AND POSSIBLE MITIGATION SCHEMES FOR PREVIOUSLY UNIDENTIFIED HAZARDS**

William Linzey, Micah McCutchan, and Michael Traskos  
Lectromechanical Design Company

Richard Gilbrech, Ph.D.  
NASA Langley Research Center

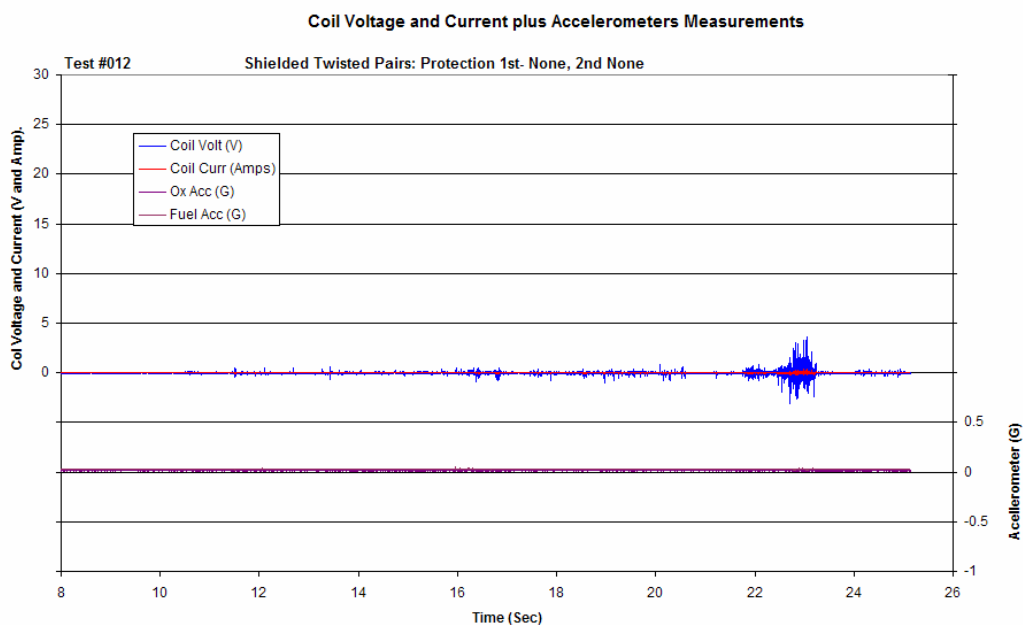
**Figure 12. Voltage and Current across the Coil and Accelerometer Measurements for Test Specimen 012**

Two groups (011-015 and 76-80) were placed in this category. The fuel/ox wires of the former were unprotected, shielded twisted pairs and the latter were twisted pairs (non-shielded) protected with one wrap of PTFE tape. Figure 12 shows the voltage and current across the coil for Test 012. There is no activity except oscillations of a few volts after the 22-second mark. These oscillations were most likely from electrical noise generated by the arcing event. The fuel/ox wire from Test 012 passed the wet DVW test indicating that there could not have been direct current going from the arc to the fuel/ox wire. Thus, there was only a capacitive/inductive coupled current. The sampling rate of the data logger was too low to obtain frequency information for the oscillations. There is no movement of the valve detected by the accelerometers.

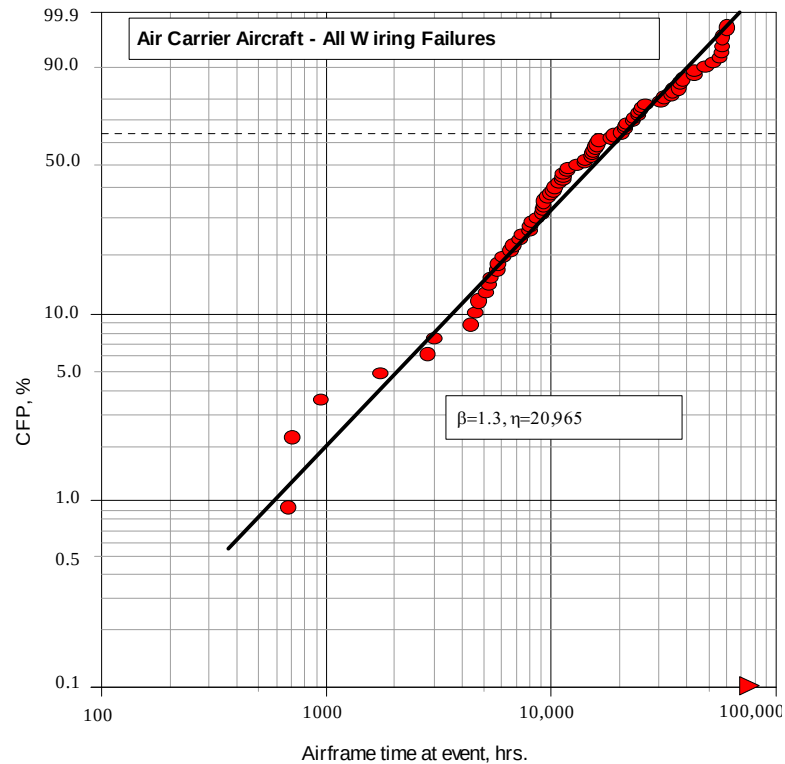
**Figure 1. Weibull Plot of ALL Wiring Failures on Air Carrier Aircraft**

All wiring failures (broken, chafed, loose, shorted and “other” failures; 250 relevant occurrences, 92 usable for Weibull) are shown in Figure 1. These data fit a Weibull distribution well ( $P_{ve} = 41.6\%^{\ddagger}$ ). For *all* wiring failures, air carrier aircraft show “early wear-out” failures as indicated by a Weibull slope ( $\beta = 1.3$ ) greater than one.

Weibull analyses typically are performed “one failure mode at a time”. That is, mixtures of failure modes can confound the data. Although Figure 1 does exhibit a good statistical fit, there is some indication modes are mixed: several lower points diverge from the main (center) distribution as do the last upper (longest time) points. Thus data were analyzed further using separate failure modes.

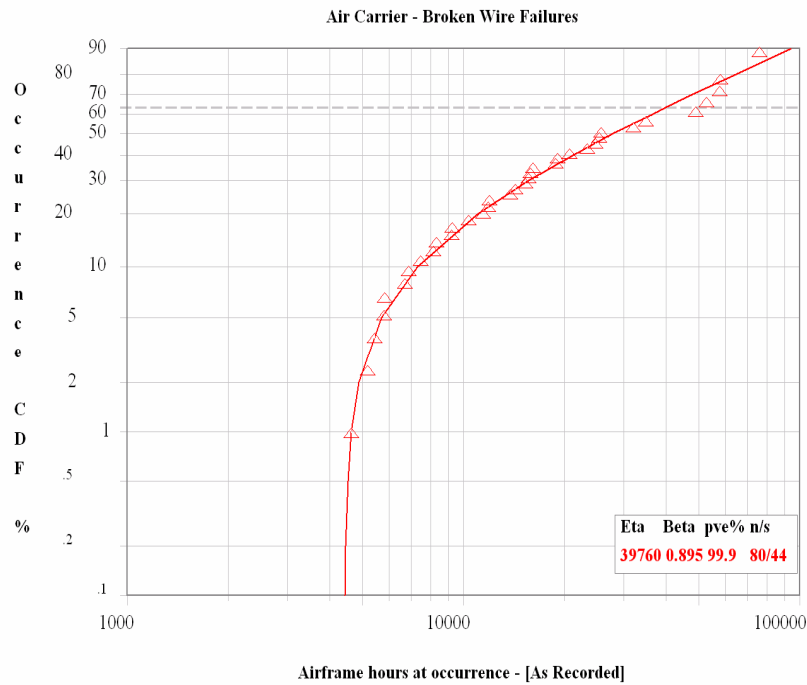
**Figure 2. Weibull Plot for Air Carrier Broken Wire Failures**

Broken wires (94 failures) initially showed a good two-parameter fit (Pve = 12.5%) with early wear-out failures ( $\beta = 1.5$ ) indicated. However, the first failure (at 1754 hours) strongly influenced the distribution. This broken wire occurred in a B737-700 causing an engine fire. Its early occurrence suggested infant mortality. Censoring this datum yielded a poor two-parameter fit (1.5%), but the curved shape suggested a three-parameter Weibull distribution. A three-parameter fit was excellent (99.9%) with  $\beta = 0.90$  and  $\eta = 39,800$  hours indicating nearly random failures ( $\beta \sim 1$ ), as shown in Figure 2. Time offset ( $\gamma$ ) was 4,433 hours, that is, 4400 hours passed before the broken wire failures commenced.

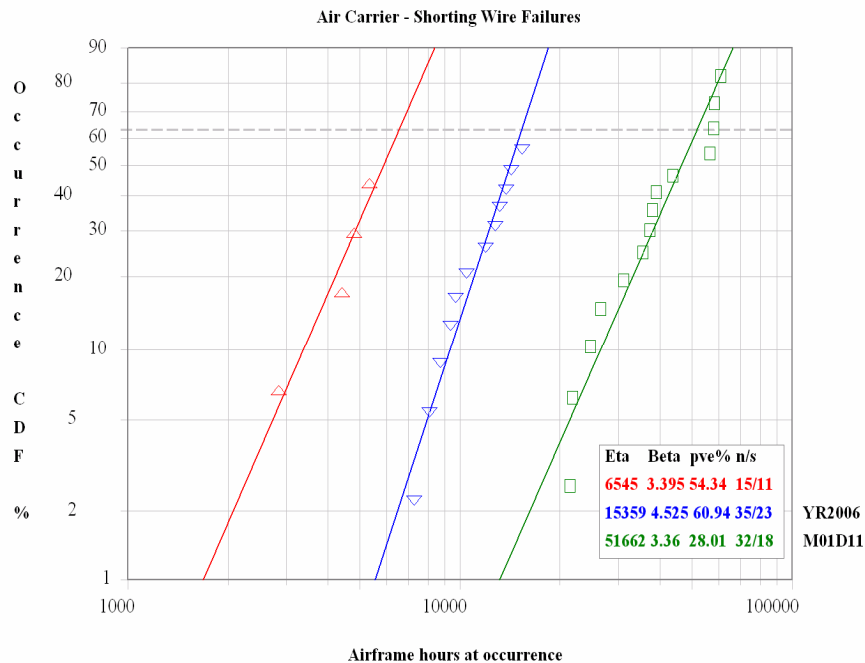
**Figure 3. Shorted Wire Failures in Air Carrier Aircraft**

The initial analysis for shorted wires (97, 31 Weibull usable) indicated early wear-out failures ( $\beta = 1.5$ ,  $\eta = 42,000$  hours, Pve = 52%). This plot showed several breaks with three or four subpopulations. These distributions were separated and plotted, as shown in Figure 3. There are three, possibly four, failure distributions with all showing greater  $\beta$ s (3.4 to 4.5) pointing to wear-out or near wear-out failures. A contour plot (Figure 4) compares three failure distributions within shorted wires:  $\beta$ 's are equivalent (contours overlap along the vertical, beta, axis), but they are separated along the eta (time) axis.

As this three distribution model is credible, aircraft wiring shorts likely manifest as wear-out failures distributed over a range of operational times. These several “large  $\beta$ ” distributions combine over a wide time scale to produce an apparent lower- $\beta$  early wear-out distribution.
